### *CASE STUDY 3*

HASTINGS AVE.

## RESIDENTIAL FLOOD PROTECTION AND STORMWATER COLLECTION

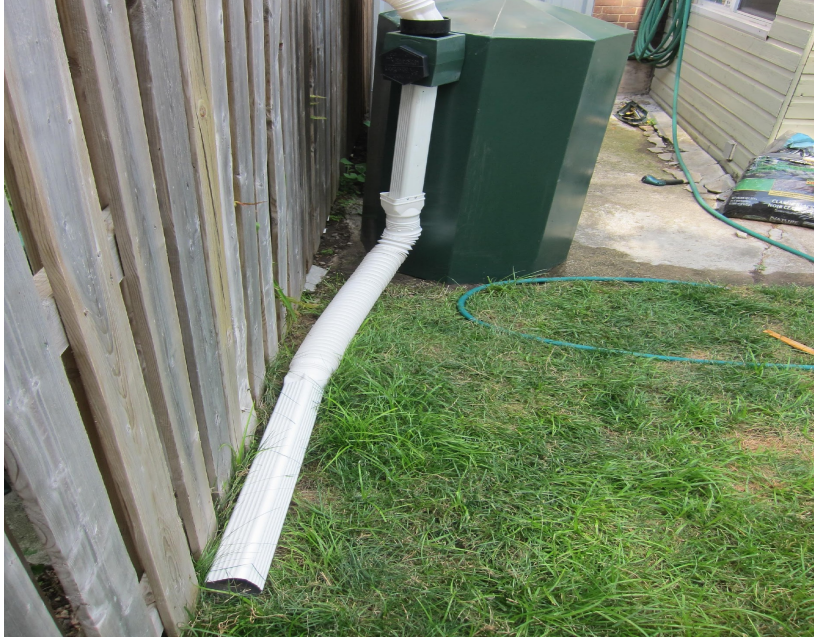
*Figure 3.2: Installed rain barrel and overflow/bypass drainage at Hastings Ave.*

**Rain Barrel:** The 500 L rain barrel was installed on the concrete patio against the fence on the north side of the property about 4 m (12 ft.) from the back of the house (see fig. 3.2). The rain barrel had to be delivered through the residence because there was not enough clearance between the houses. Some gutter work was done by the homeowner to bring the downspout from the south side to the north side of house. The roof collection surface was estimated at approximately 6 x 7.5 m (20 x 25 ft.), or 46.5 m<sup>2</sup> (500 sq. ft.). A standard 7.5 x 5 cm (3 x 2 in.) downspout, running along the back fence and fitted to our customized storm funnel, connects to the diverter box. This backyard has an excellent drainage profile, due to sandy loam soil and no tree cover over the roof collection area.

**Overflow, Bypass and Drainage:** A 6 m (20 ft.) garden hose runs from the rain barrel discharge tap to the backyard, and an overflow/bypass capacity drains to the backyard by a flexible 10 x 10 cm (4 x 4 in.) extender pipe (see fig. 3.2). Soils are sandy loam and drain very quickly. No soaker hose was used on this system.

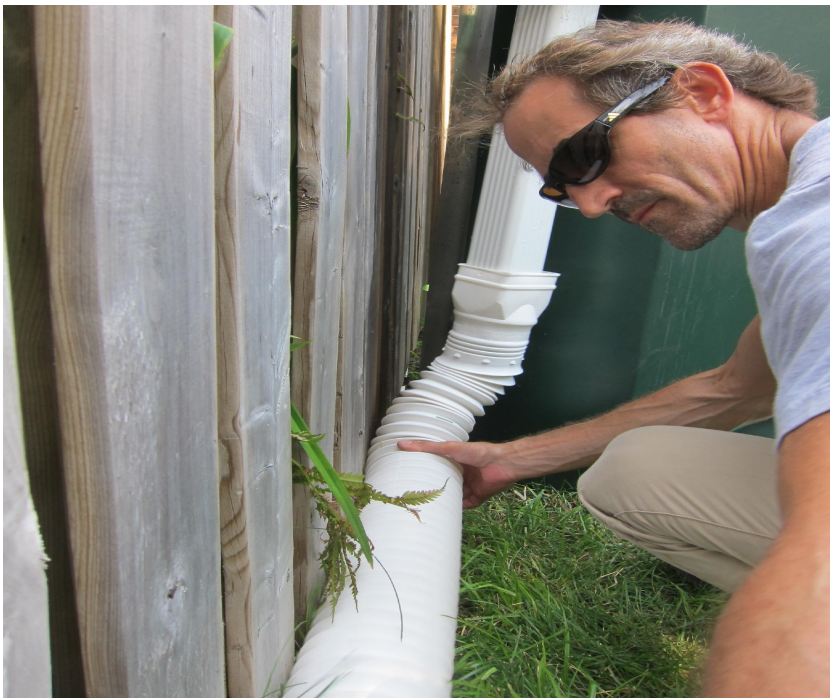
*Figure 3.3: Positioning overflow/bypass along the fence to the Hastings Ave. backyard.*

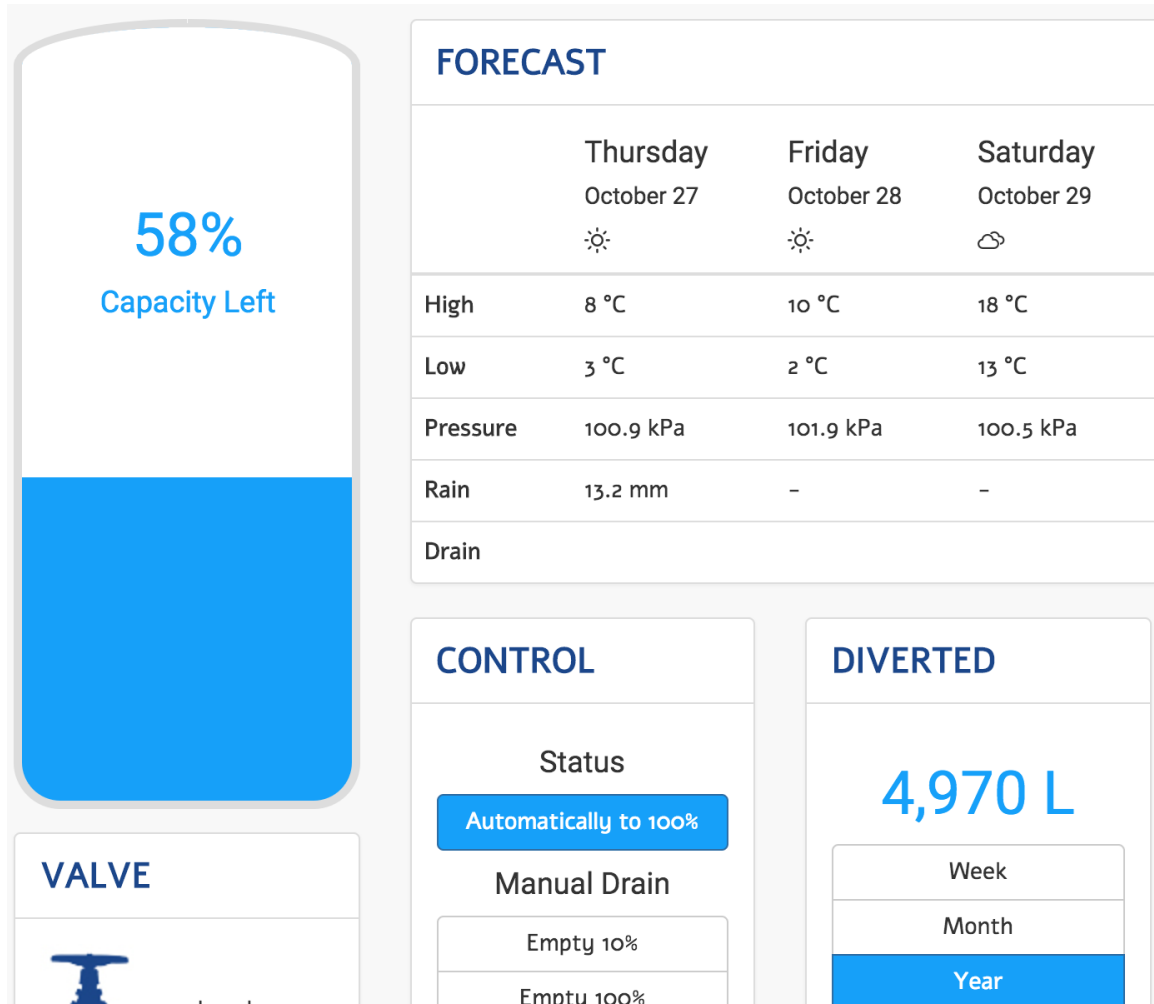
Figure 3.8: Total Collection Volume From June 26 to Oct 27
